REV. A	PART NUMBER LPI-C011701S-150R	<p>CONFIDENTIAL INFORMATION</p> <p>THE INFORMATION CONTAINED IN THIS DOCUMENT IS THE PROPERTY OF LUMEX INC. EXCEPT AS SPECIFICALLY AUTHORIZED IN WRITING BY LUMEX INC, THE HOLDER OF THIS DOCUMENT SHALL KEEP ALL INFORMATION CONTAINED HEREIN CONFIDENTIAL AND SHALL PROTECT SAME IN WHOLE OR IN PART FROM DISCLOSURE AND DISSEMINATION TO ALL THIRD PARTIES.</p>

<p>290 E. HELEN ROAD PALATINE, IL 60067-6976 PHONE: +1.847.359.2790 US WEB: www.lumex.com TW WEB: www.lumex.com.tw</p>
SINGLE UNIT PANEL MOUNT FLEXIBLE LIGHT TRANSPORTER, RED LENS.		<p>RELIABILITY NOTE</p> <p>OUR MANY YEARS OF EXPERIENCE DATA ACCUMULATION INDICATE THAT SOLDER HEAT IS A MAJOR CAUSE OF EARLY AND FUTURE FAILURE. PLEASE PAY ATTENTION TO YOUR SOLDERING PROCESS.</p>	DRAWN BY: JC CHECKED BY: APPROVED BY:
		DATE: 9.16.02 PAGE: 1 OF 1 SCALE: N/A

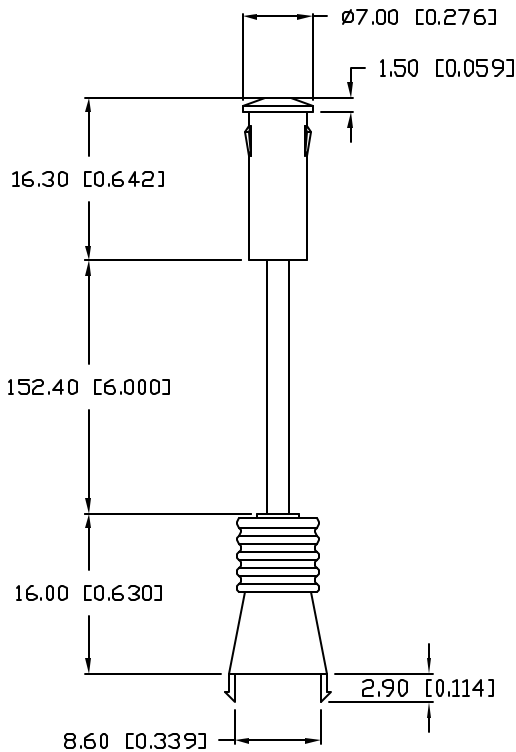
PANEL CUT OUT: $\phi 6.00\text{mm}$.
 PANEL THICKNESS: $1.80\text{mm} \sim 4.80\text{mm}$.
